EXIDE
TECHNOLOGIES
913 South 10th Street
Manchester, IA 52057

RE: Exide Technologies – Manchester, Iowa
EPA ID: IAD069619765
Follow up to Notice of Preliminary Findings – Inspection 05/24-05/25/17

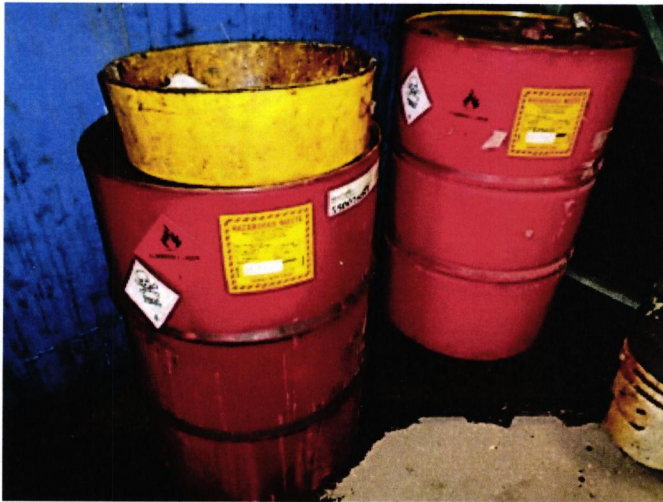
Before

3. **Preliminary Finding:** Failure to close hazardous waste satellite accumulation container, 40CFR262.34(c)(1)(i) and 40CFR265.173(a).

Response/Action: The drum in question is the maintenance shop Waste Oil drum. A latching funnel was purchased immediately and installed on all waste oil satellite storage areas. The "before" and "after" pictures can be seen below.

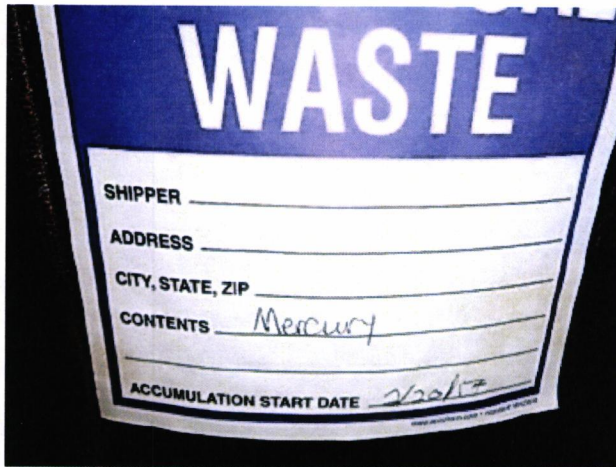
Previous label

7. **Preliminary Finding:** Failure to label Universal Waste mercury containing equipment container with the words, "Universal Waste Mercury Containing Equipment" or "Waste mercury containing equipment," or "Used mercury containing equipment," 40CF273.14d)(1)

Response/Action: The wording was revised at the time of the inspection. Labels with a selection of Universal Waste names were purchased to use on future containers to eliminate the alternate waste names. The site will temporarily continue to use the larger purple label with the words "UNIVERSAL WASTE" but will include the smaller label from which to select a named waste stream and to document the accumulation start date. The plant will transition

to using only the new labels when the existing supply of the previously used labels is exhausted. Examples of a previous label and the new labeling system are shown below.
